## OPERATIONAL SAFETY NOTICE

### Rolls-Royce M250 Engines: Maintenance Warning – External Lines

# ALERT COMMERCIAL SERVICE LETTER

## MAINTENANCE WARNING - EXTERNAL LINES

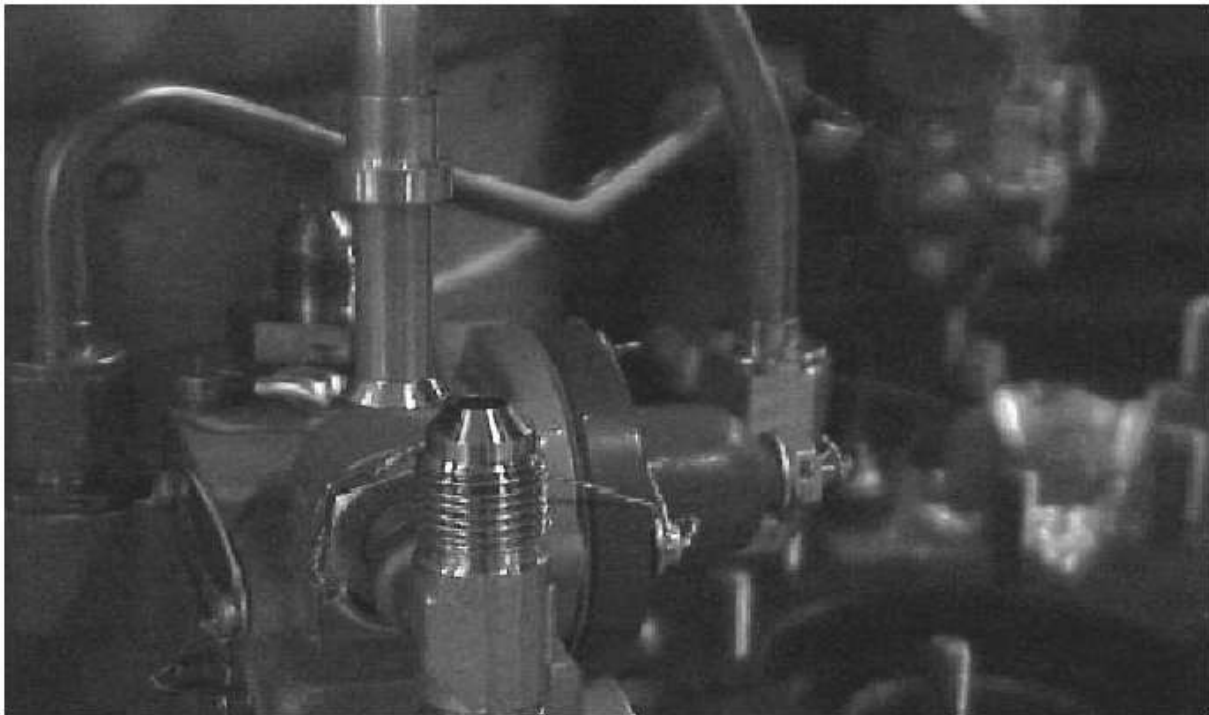
Misaligned Tube  
FIG. 5

- C. Always use a torque reaction wrench when tightening tube assembly B-nuts.
- D. Tube assemblies must fit and be aligned with the mating flare tube fittings to the degree that at both ends of the assembly, the flares shall be uniformly seated in a free state on the cones of the mating fittings. The fitting shall be without distortions or stretching of the tube assembly, and to the degree that the nuts can be fully engaged up to the final one-half turn with light finger pressure. See [Figures 5](#) and [6](#).

- E. In the event that a tube does not align with the mating fittings, re-position the mating fittings to the degree that proper alignment may be attached. Final tightening of these fitting lock nuts must be accomplished before the tube assembly is torqued.

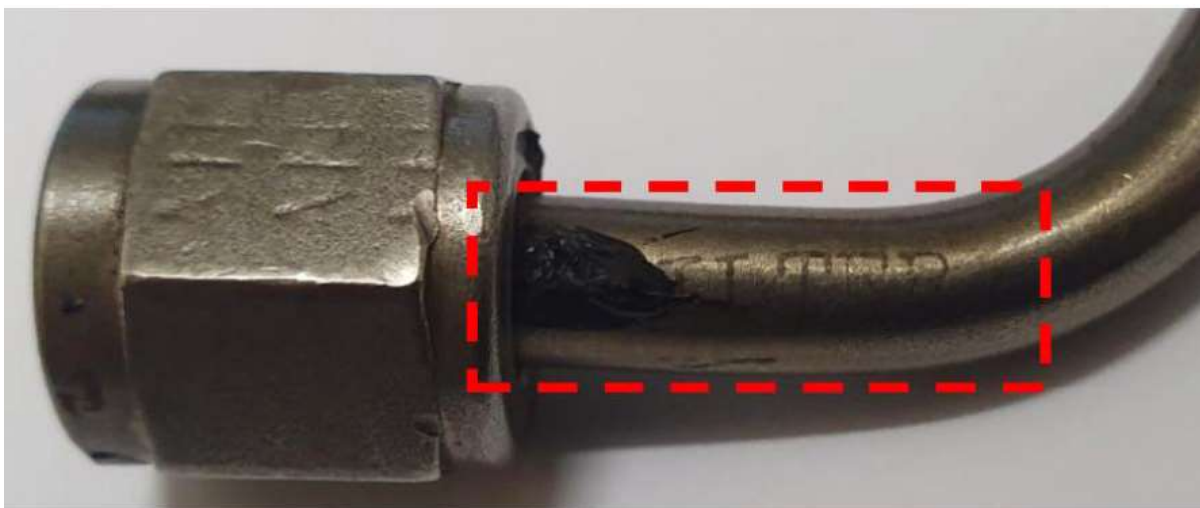
P/N 23051141 tube assembly was removed from a C20J engine after experiencing an in-flight power loss, followed by a hard landing. Photographs were taken of the tube while installed and after being removed as shown in [figures 9](#) through [11](#). The following discrepancies were noted during the examination of the tube assembly:

- A. The tube was corroded at both ends near and underneath the ferrules.
- B. The tube was installed backwards. The word "FILTER" is etched on the tube to indicate the end that should be adjacent to the Pc filter when installed.
- C. The separation between the tube's fracture surface and the B-nut attached to the filter indicates the tube was under stress due to misalignment.
- D. This aircraft had spent several years in a coastal environment, which likely contributed to the corrosion seen on the tube.

Orientation Mark  
FIG. 9

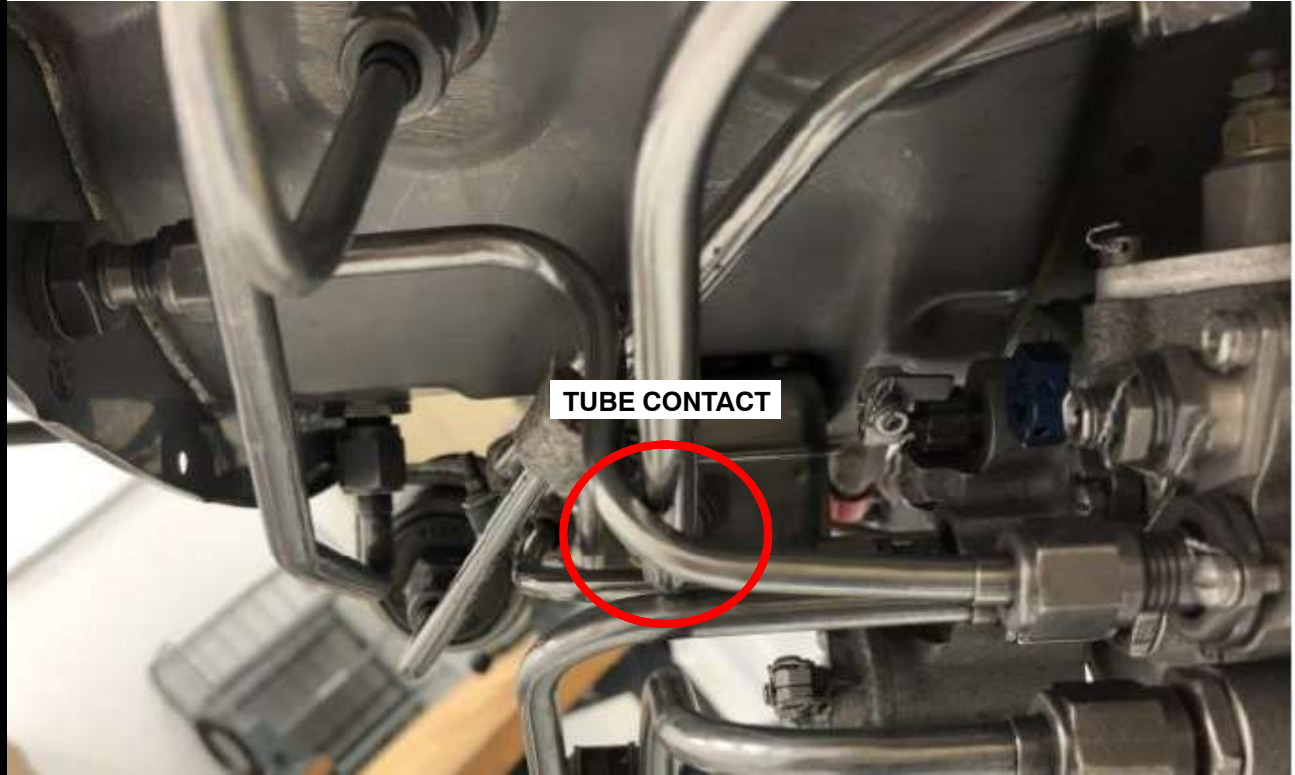
Incorrect Installation  
FIG. 13B

Two tubes can fit either way, but one way results in contact with another tube. In this case, one must ensure that the orientation with the largest clearance from other tubes is selected. These tubes are:

- 6844169 Series II FCU-to-fire shield (Figure 13)
- 6890580 Series III/IV FCU-to-fire shield (Figure 14).

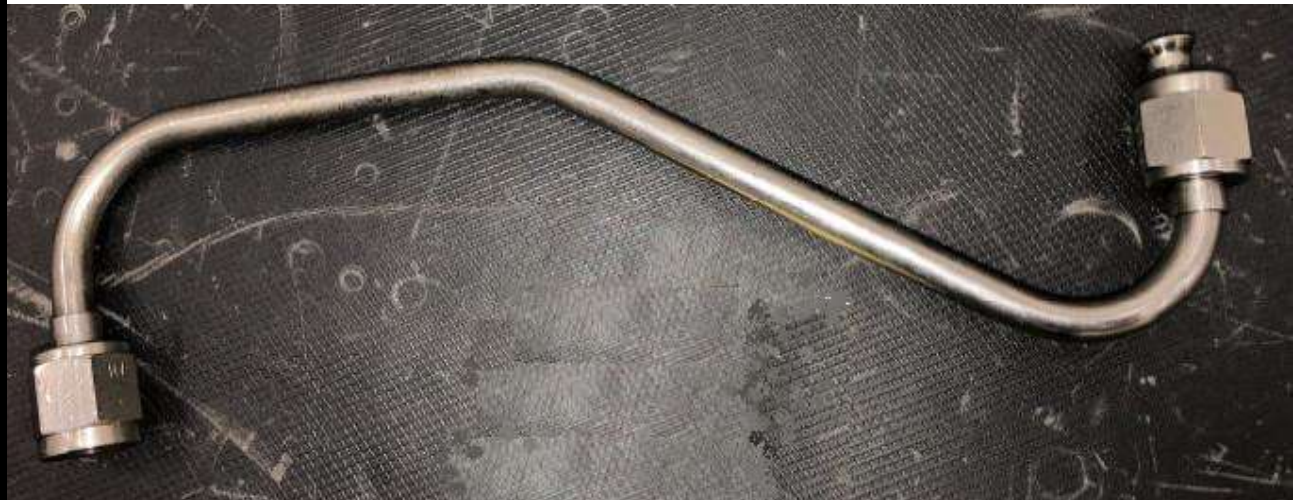
6890580 FCU to Fire Shield Series II  
FIG. 14

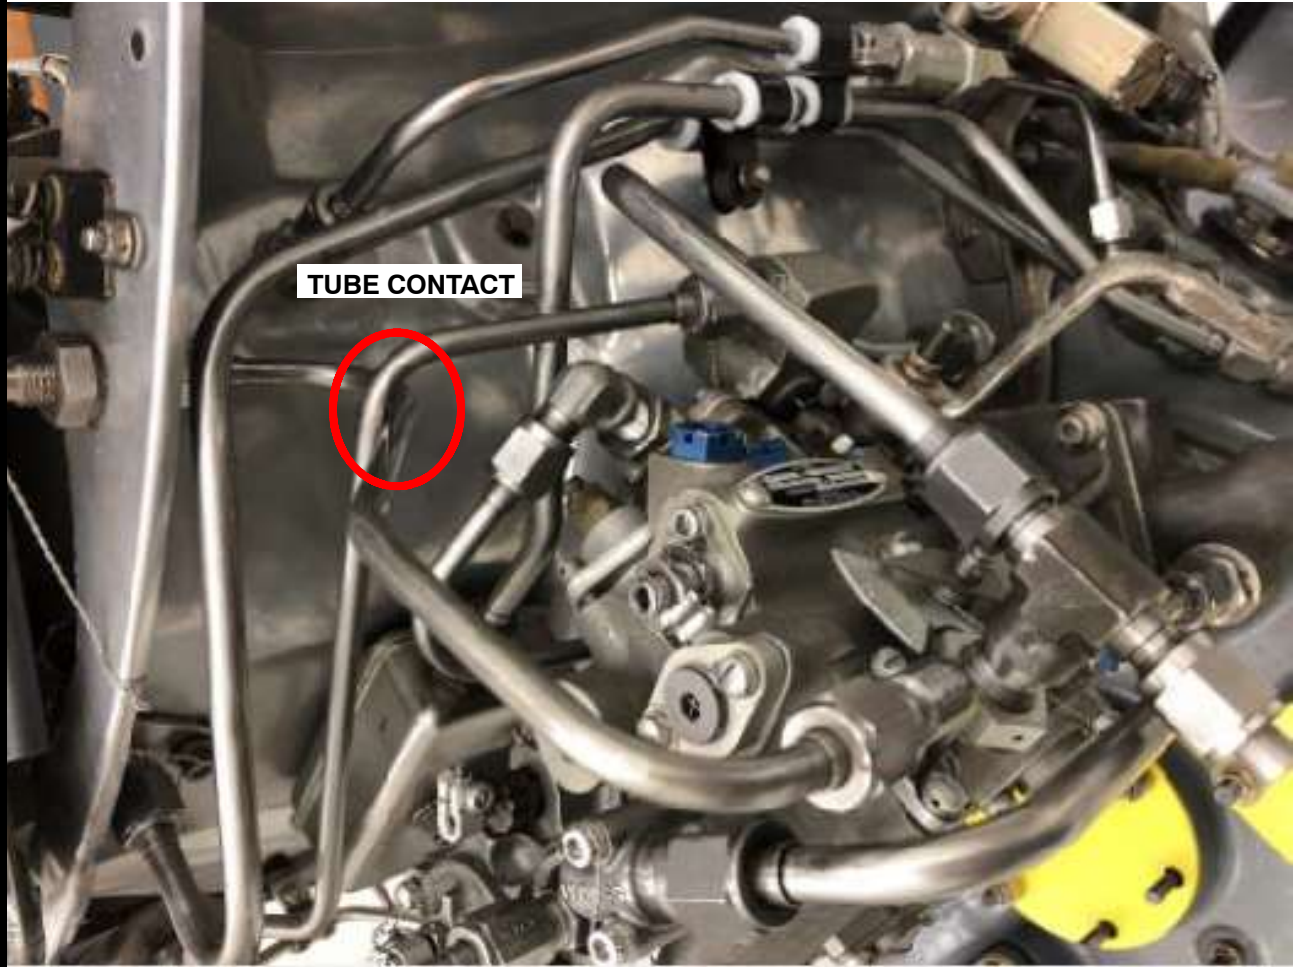
Incorrect Installation  
FIG. 14B

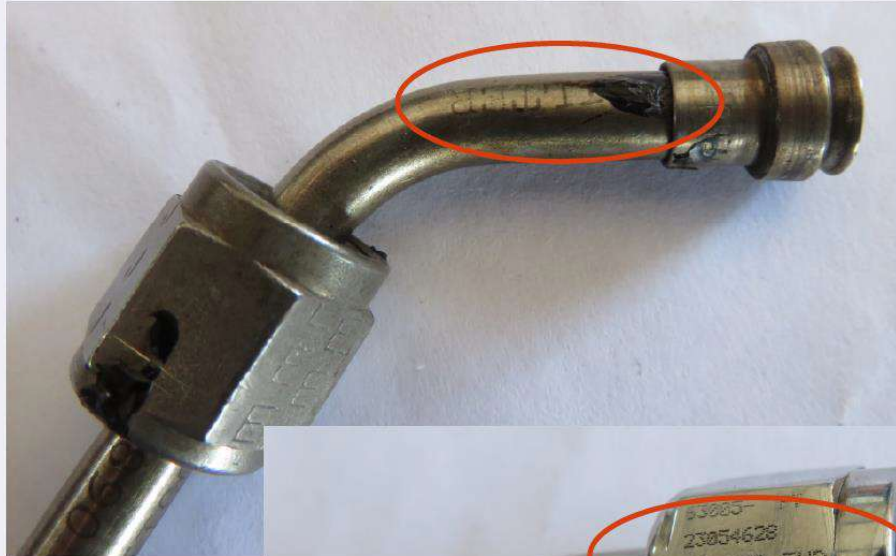
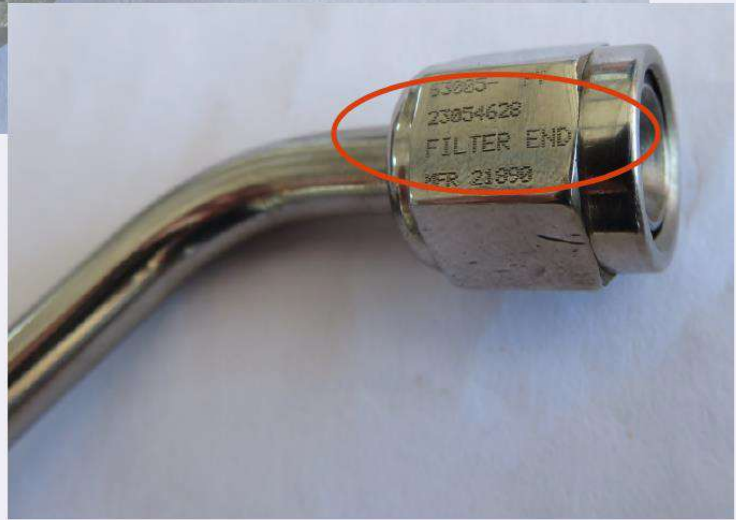
Tube End Marking  
FIG. 16

R. Ensure proper orientation of tubes during installation. Several tubes are marked either on the tube itself or the B-Nut to indicate proper orientation. These include:
